BAER Scientists and Specialists Assess the McKinney Fire – What They Do

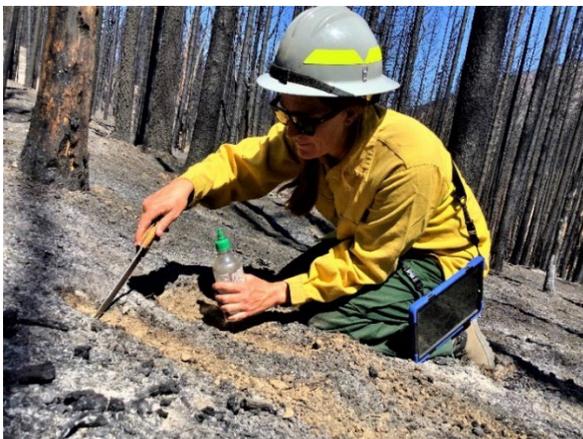
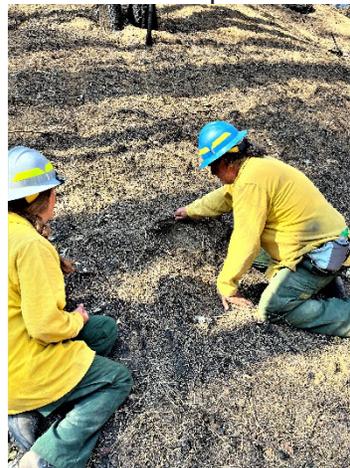
Below, these three photos show Forest Service Soil Scientist Eric Nicita and Hydrologist Jesse Merrifield assessing soil hydrophobicity (water repellency) and changes to soil structure in a high soil burn severity (SBS) area of the McKinney burned area. Jesse digs a trench and drops water on the soil at multiple depths to determine how deep and how strong the layer of water-repellant soil may be.

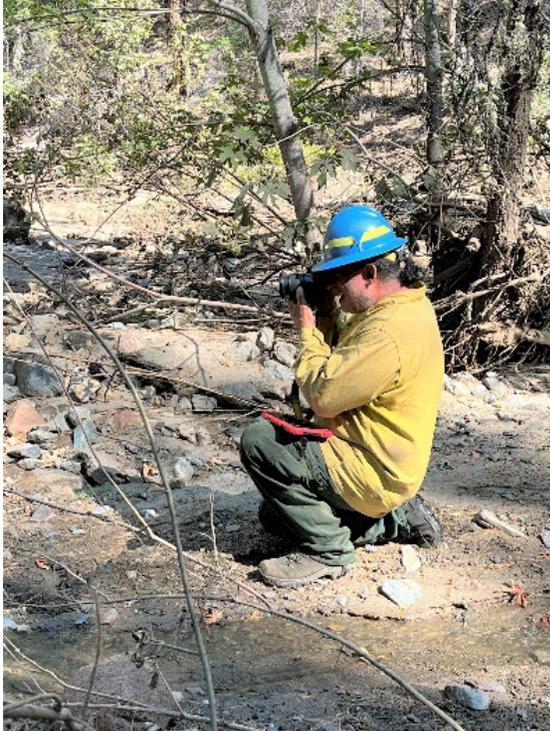
In this photo below, Eric Nicita is assessing and recording data about potential debris flow damage in a McKinney burned watershed.

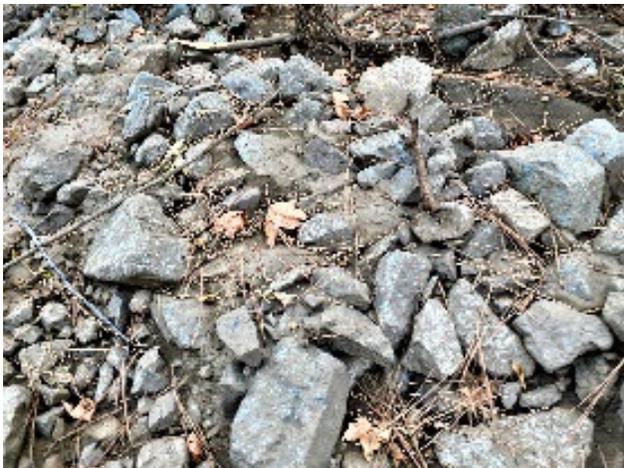
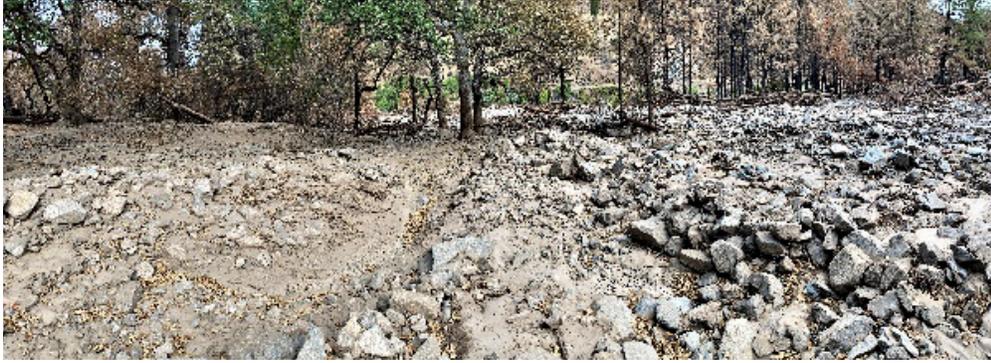
The two photos below were taken by Forest Service Hydrologists Kyle Wright and Jesse Merrifield during their field assessments of the McKinney burned area. The top photo shows evidence of prior debris flow material in Little Humbug Creek, while bottom photo shows past debris flow deposits near the confluence of Vesa Creek and the Klamath River.

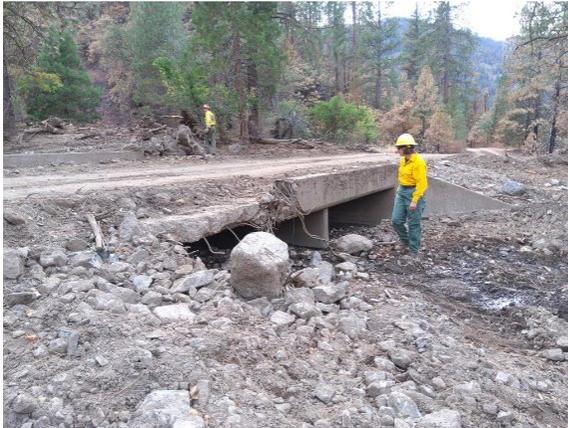
In the next photo below, Kyle Wright and Forest Service Hydrologist Anna Chinchilli inspect damage at the bridge crossing Vesa Creek on the Klamath River Road following the August 2, 2022, debris flow event. Immediately after this event, only a couple inches of space were observed between the entrained material and the base of the bridge. The bridge inlet/outlet was cleared by heavy machinery to allow water to pass unobstructed.

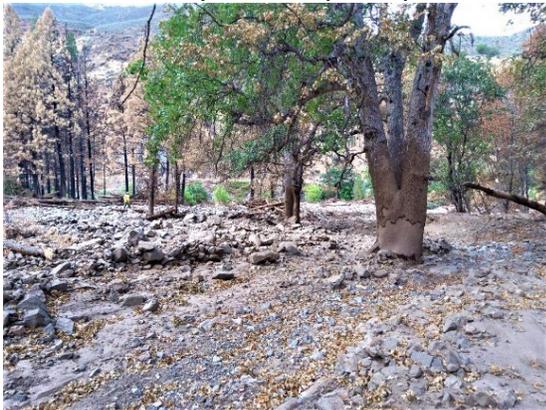
In the next photo below, a high debris flow mud splatter is visible on oak trees resulting from the August 2 Vesa Creek debris flow event at the confluence of Vesa Creek and the Klamath River. Kyle Wright is in the background walking past large, coarse, woody debris piles pushed out during this event.

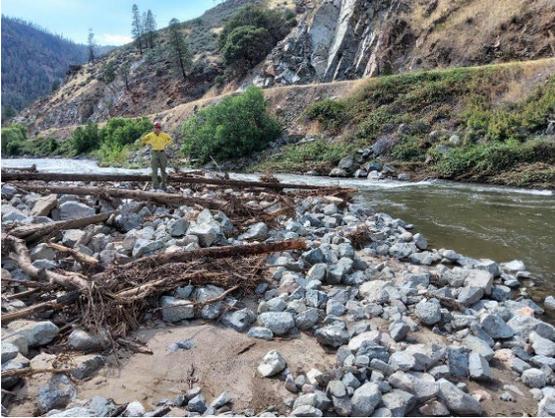
This next photo shows Kyle Wright standing on the remnant Vesa Creek debris flow fan at the confluence with the Klamath River.

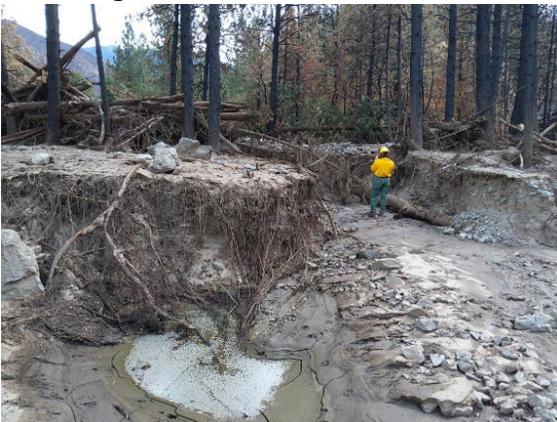
Forest Service Hydrologist Anna Chinchilli is documenting a head-cut created during the Vesa Creek debris flow event where water carried sediment, rocks and other debris during the event and cut into the adjacent less-armored upland soils resulting in vertical erosion.

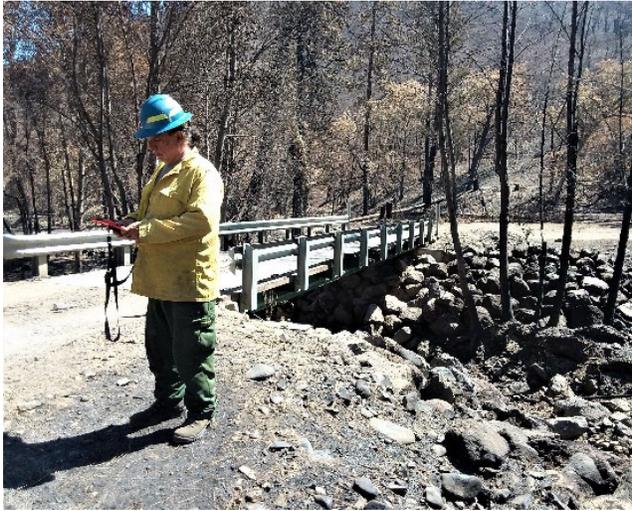
In this photo below, Eric Nicita is assessing fire damage to a bridge.

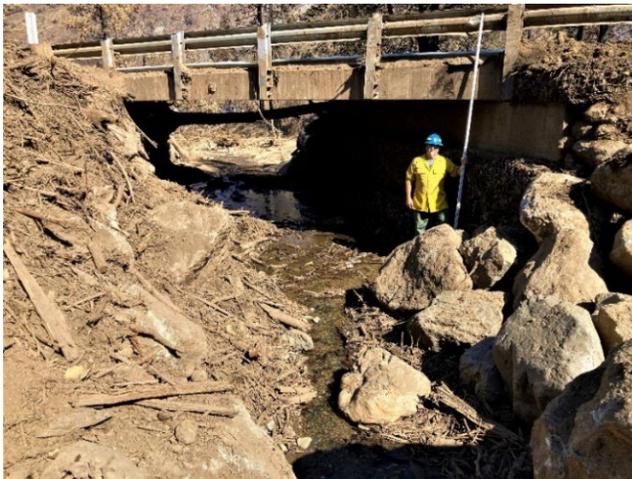
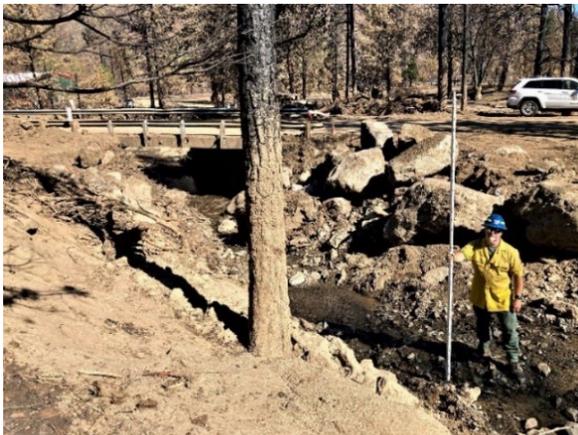
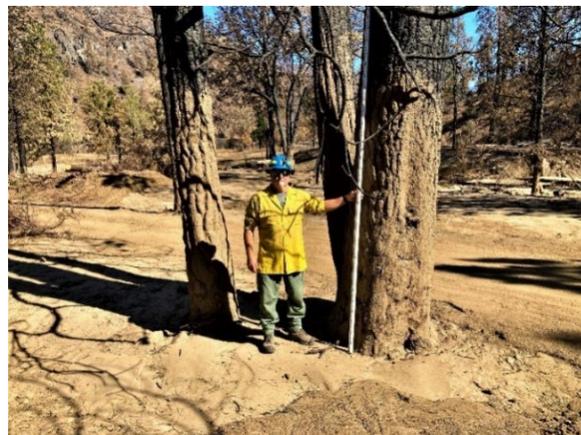
The next three photos show BAER Geologist Dennis Veich while he and Forest Service Geologist Yonni Schwartz were measuring the depth of inundation (impacts) by the August 2 debris flow event at a bridge just above the confluence of Little Humbug Creek and the Klamath River in the McKinney burned area.

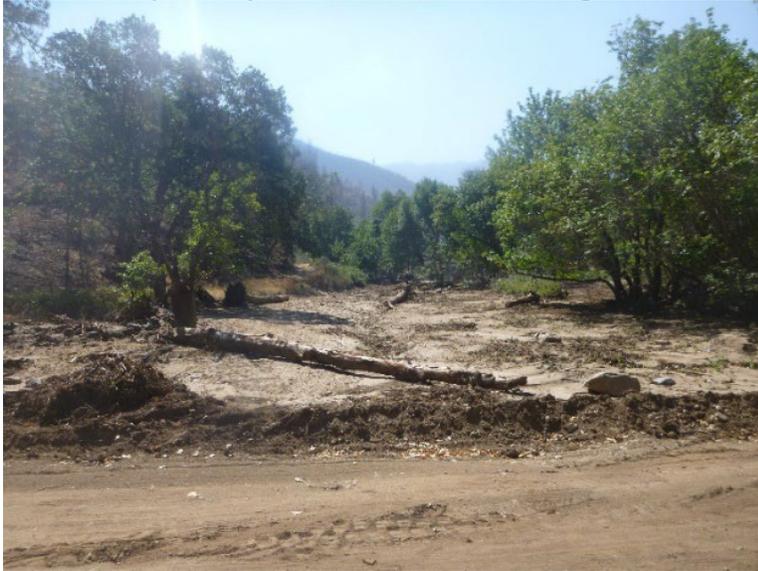
This photo shows Vesa Creek looking up-canyon from County Road 8J001 where creek temporarily diverted from the original stream channel, crossing the road.

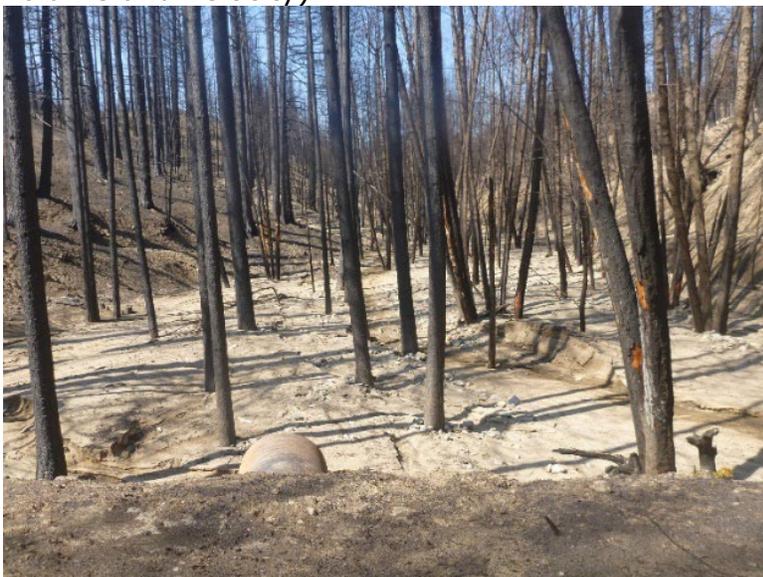
This next photo is a Humbug Creek area that is a typical example of a side drainage area that was overwhelmed by the August 2 storm event. A primary culvert under the county road was also plugged. The culvert in this photo is a high relief culvert (relieves surface water runoff from roadside ditches to prevent excessive water volume and velocity).

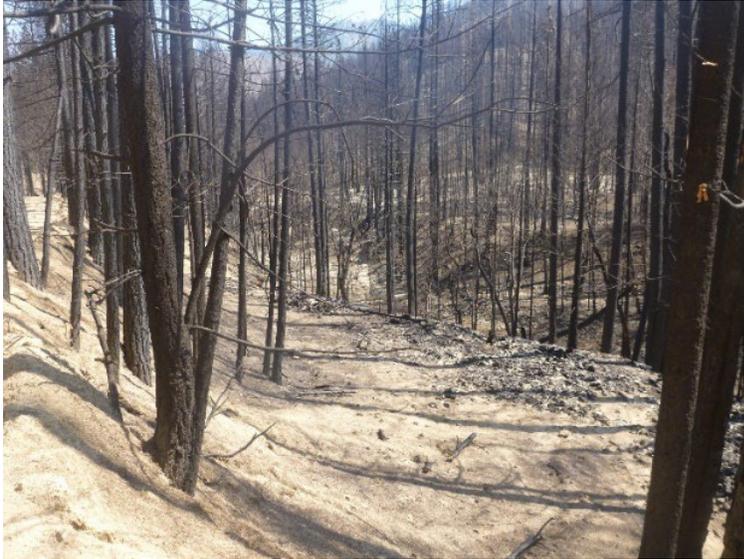
Below is an example of a severely soil burn severity riparian area in Humbug Creek between Lawson Gulch and Sucker Creek.

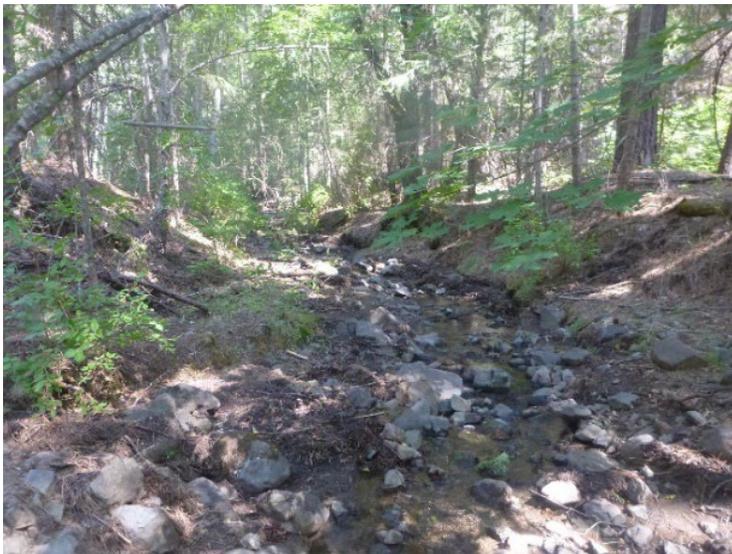
Here is a riparian area of Humbug Creek just downstream of Eliza Gulch that has an unburned to low soil burn severity which also includes most of the creek's tributaries. There is no sign of sediment impact beyond what is considered normal for this drainage despite evidence of elevated flows from the August 2 rainstorm event.
